24 July 2007  
Proj. No.: DS02770  
SF: 42875.1  
LCh/LOB/ML

**DMRI Consult**

## **Investigation of pig transports for more than 8 hours in cold and warm weather conditions and of the requirements for ventilation during the transport**

Leif Lykke (formerly Leif Christensen), Lars Blaabjerg and J. Hartung

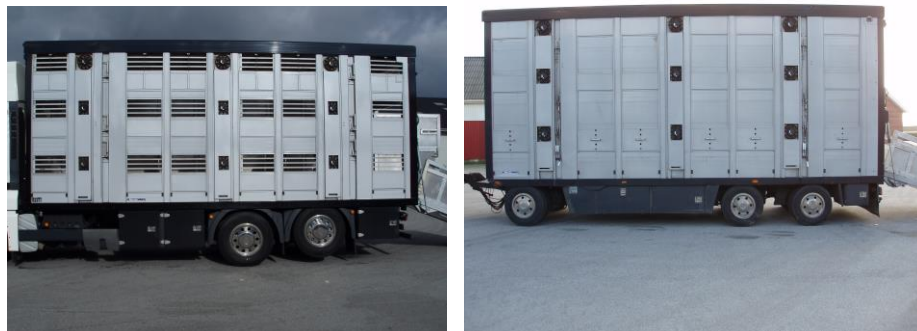
**Figure 1.**

The transport vehicle used for the investigation comprises a fore carriage and a hanger. The picture on the left shows the vehicle body of the fore carriage with ventilation openings open. The picture on the right shows the body of the hanger with ventilation openings closed.

The mechanical ventilation as well as the misting system is not operated by the actual temperature in the truck body. Sensors mounted on the front-board of the lower, front compartment on the fore carriage gives information to the driver of actual temperatures via a display in the driver's cab, and the driver has to start-up the mechanical ventilation and misting system when he receives the information on the display.

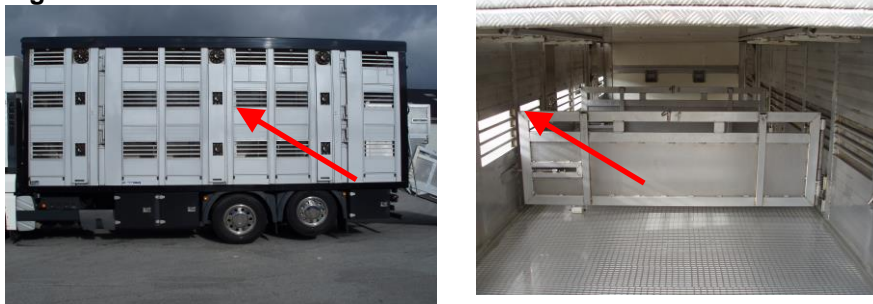
**Figure 2**

- The ventilators: when the temperature in the compartment reached approx. 20°C
- Misting system: when temperatures get above 25°C

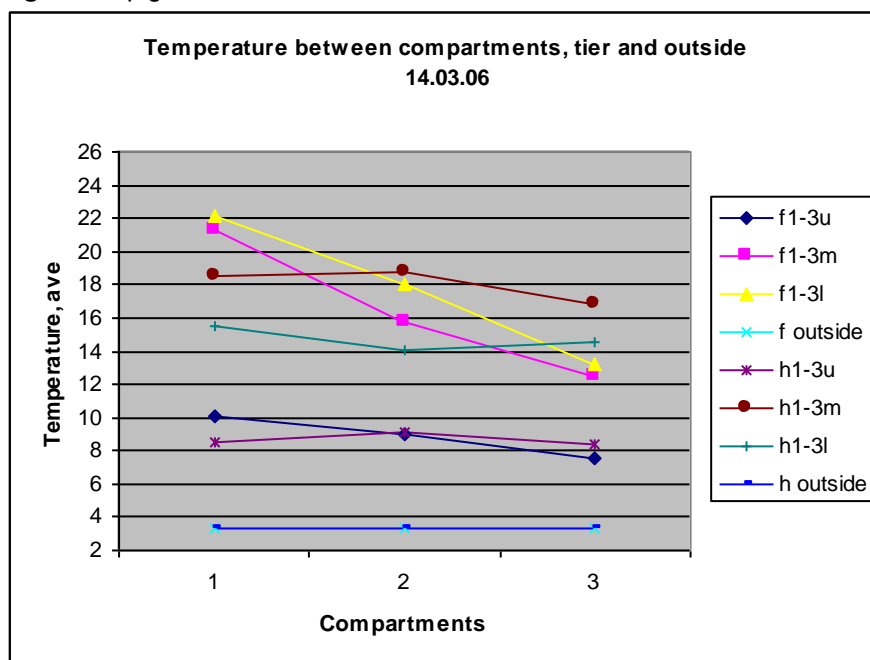
**Figure 4** - piglets

A slight increase in temperature is seen in compartment H2M, H2U and H3L, compared to the neighbouring compartments. The increase in temperature is approx. 0.5°C.

The temperatures between compartments, tier and outside the vehicle on the first day of the winter transport of piglets, slaughter pigs and sows are shown in Figures 4 to 6. The temperature normally drops from the front and to the rear end of the vehicle, and therefore it seems a few times that there is a slight increase in temperature of 0.5 to 1.0°C.

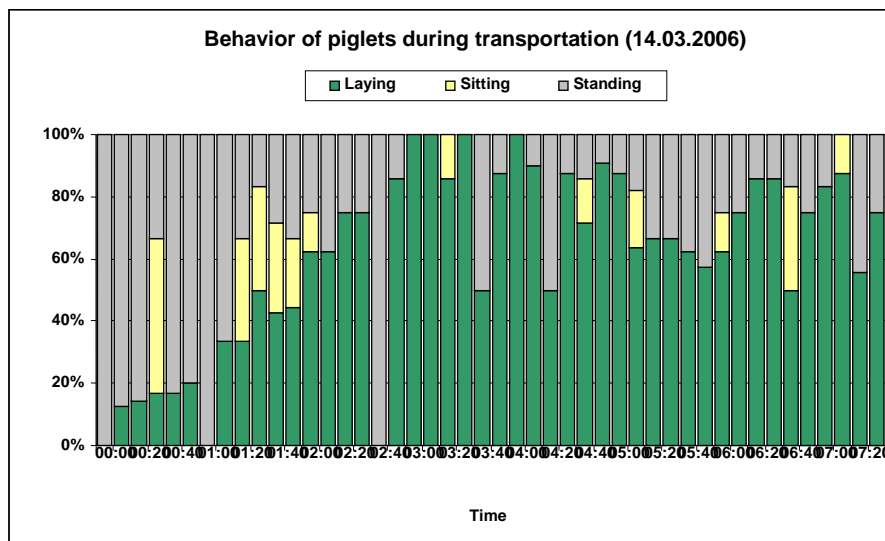
**Figure 15** – Distribution of piglets lying down, sitting or standing during a randomly chosen winter transport

Figures 15 and 16 illustrate the corresponding distribution for 2 randomly chosen transports carried out during winter and summer periods.

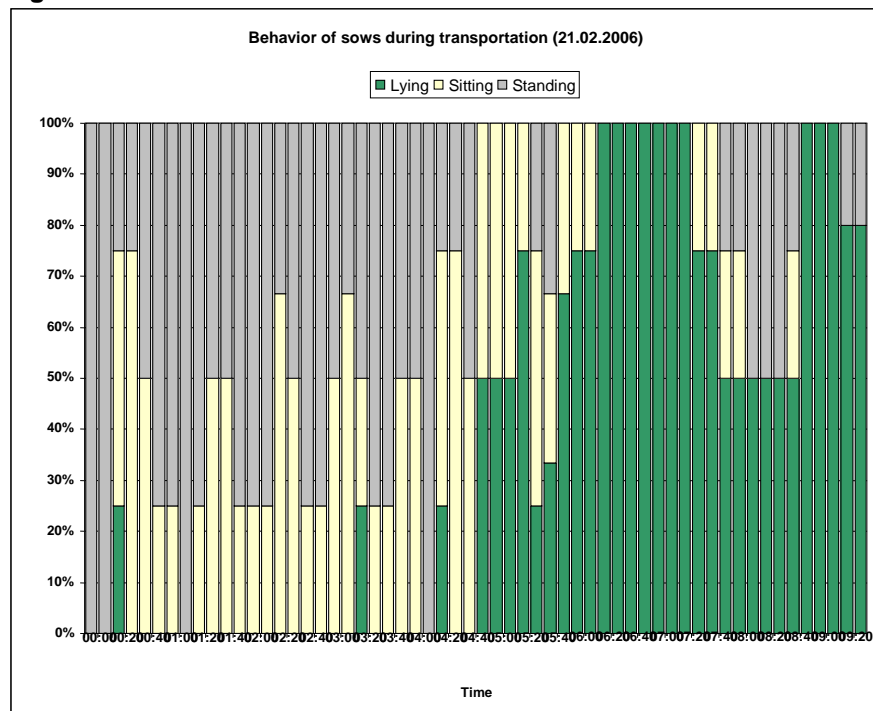
**Figure 35**

One observation represents 6 sub observations distributed over 60 seconds.

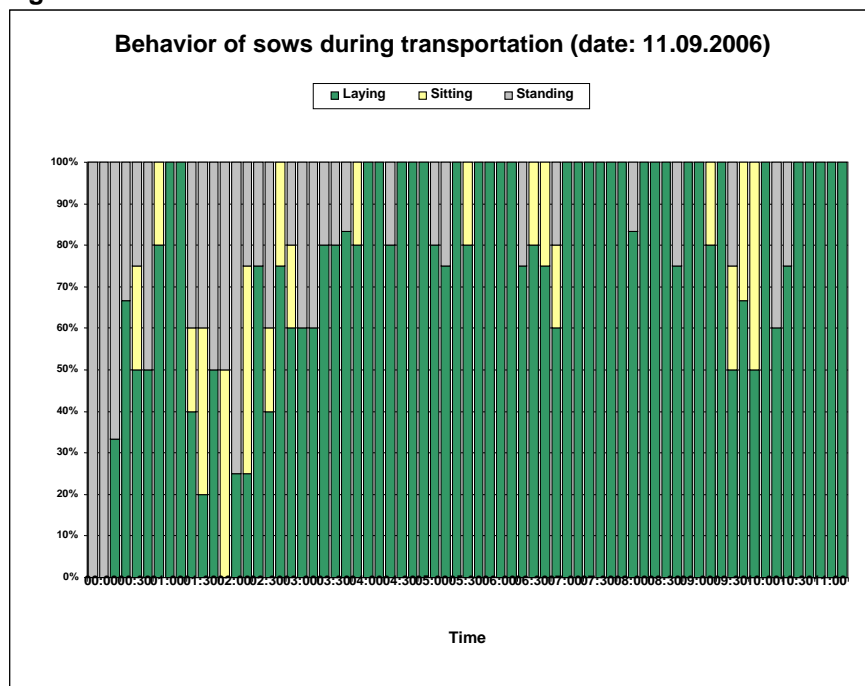
**Figure 36**

One observation represents 6 sub observations distributed over 60 seconds.

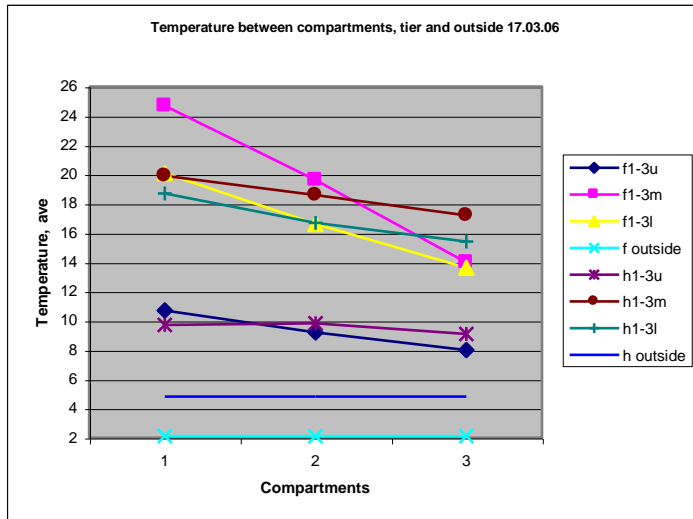
Piglets – Temperatures, correlation between fore carrier, tier, compartments and outdoor, winter

For an overview of all transports, see Attachment 5.

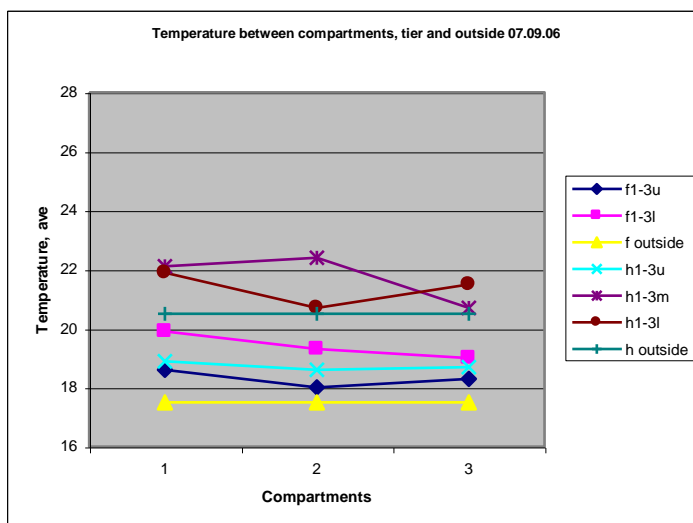
Slaughter pigs – Temperatures, correlation between fore carrier, tier, compartments and outdoor, summer

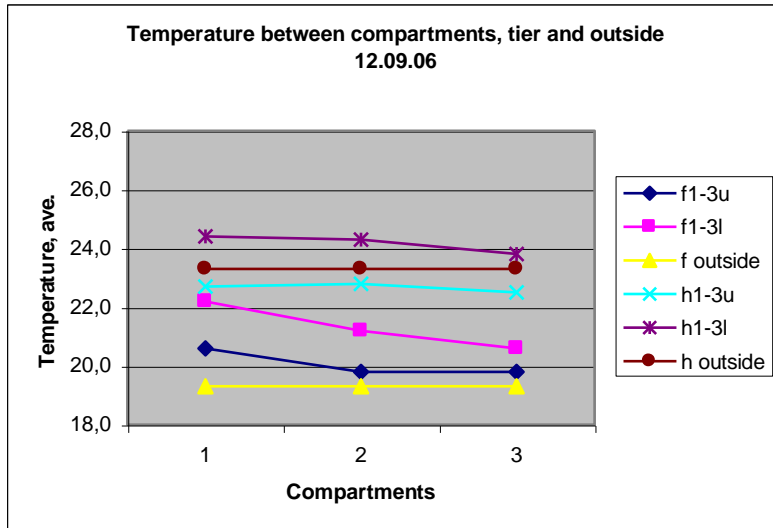
Sows – Temperatures, correlation between fore carrier, tier, compartments and outdoor, summer

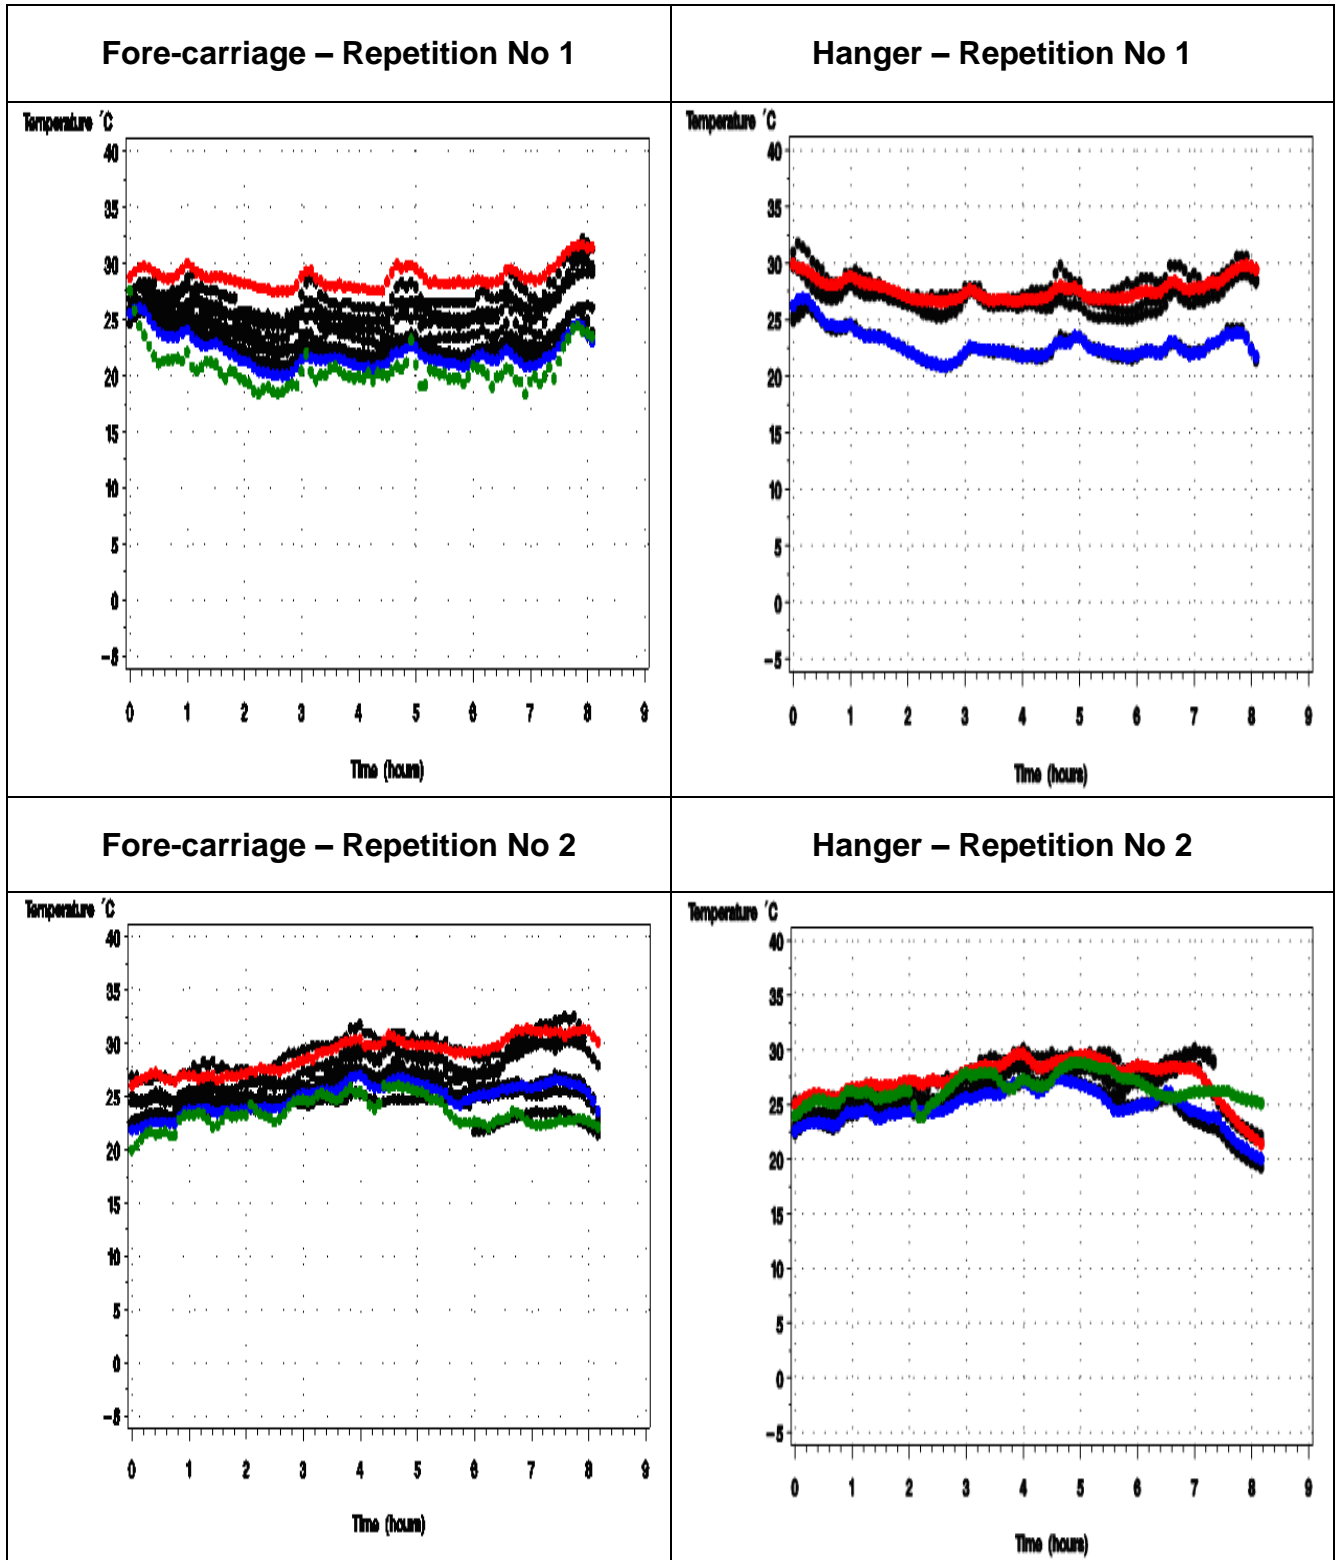
Temperature over time during summer transports

○ Logger in F1L/H1L    ○ Logger in F3U/H3U    ○ Rest of loggers    ○ Outdoor logger

The highest average temperature registered for the longest time was in the compartments closest to the driver's cabin on the lower and middle decks of the fore-carriage. On the hanger, the highest temperature sequences were found on the middle deck in the front room. The lowest temperature sequences over time were found on the upper deck in the rear compartments on the fore-carriage as well as on the hanger. No seasonal variation was registered, see Figure 9 and 10. Course for temperature measuring points are shown in Attachment 11
